# Manhole Inspection Summary

Manhole # S13EE\_002MH

Insp Date: **9/20/07 12:52 PM**

**Location** Address: **REAR OF 2812 ELLICOT DWI** Cross Street: **DUKELAND ST**

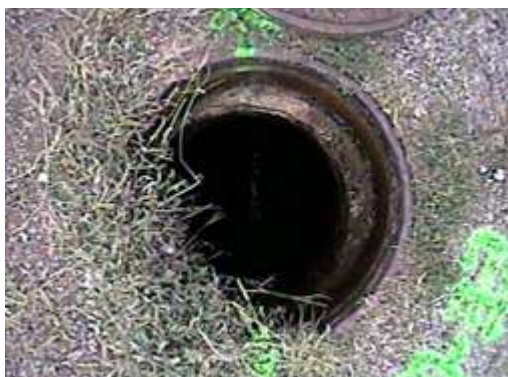
Top View

**Frame** Offset: **3** (in.) Condition: ☒ Sound ☐ Cracked ☐ Leaks

FRAME OFFSET

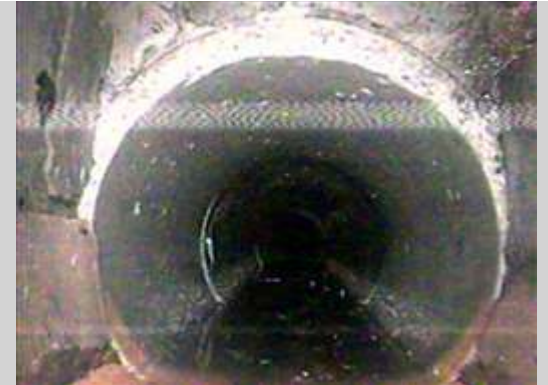
12 O'Clock Outflow

8 in. Circular Gravity Sewer  
Pipe Out @ 12 O'Clock

Invert Depth: **9.80** (ft.) Flow Characteristics: **Slow**

Deposits: ☒ None ☐ Mud ☐ Sludge ☐ Debris ☐ Grease

Infiltration: **None** Pipe Seal Cond: **Sound**

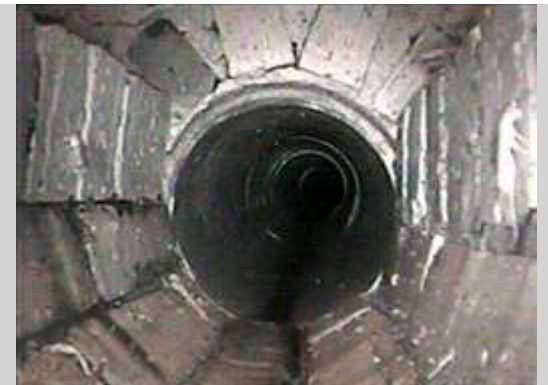
6 O'Clock Inflow

8 in. Circular Gravity Sewer  
Pipe In @ 6 O'Clock

Invert Depth: **9.70** (ft.) Flow Characteristics: **Slow**

Deposits: ☒ None ☐ Mud ☐ Sludge ☐ Debris ☐ Grease

Infiltration: **None** Pipe Seal Cond: **Sound**
